# NEW FINDINGS IN FIRE PREVENTION AND FIRE FIGHTING OF PV INSTALLATIONS

Prof. Urs Muntwyler

Berne University of Applied Sciences (BFH), Engineering and Information Technology  
Photovoltaic Laboratory (PV-Lab), Jlcoweg 1, CH-3400 Burgdorf, Switzerland  
phone: +41 (0)34 426 68 37, fax: +41 (0)34 426 68 63, urs.muntwyler@bfh.ch

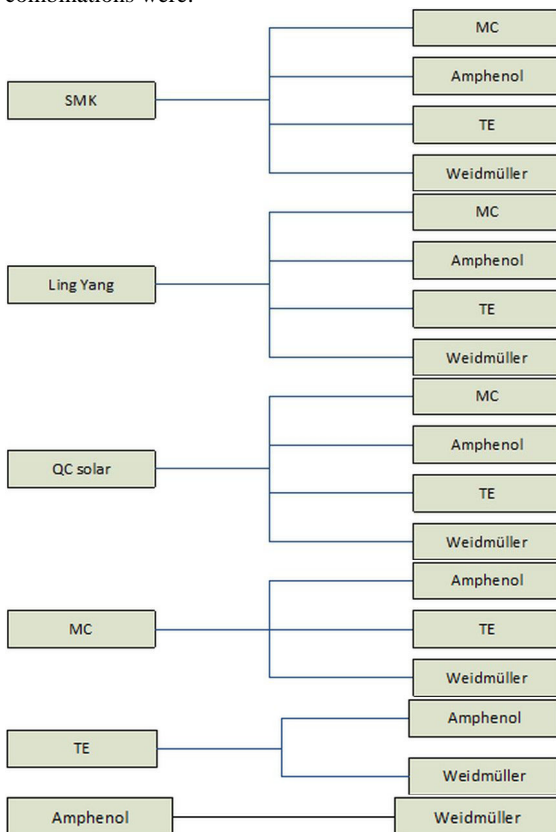
Figure 2: Connector combination for the test

We used three samples for all the combinations to have enough samples for further tests. The test combinations were:

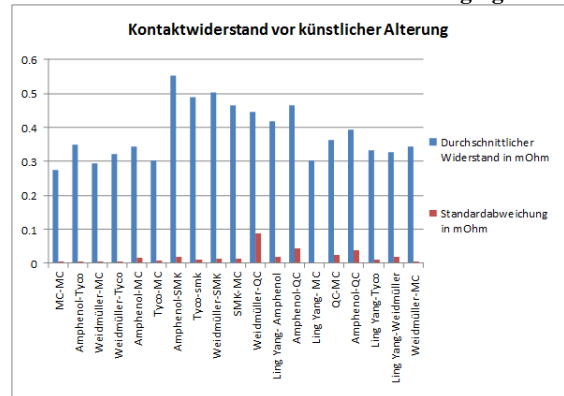
Figure 4: Contact resistance before the artificial aging [mΩ]

The differences in the resistance of the different combinations are relevant, but still in a small band. With the nominal current of 30 A the temperature enhancement is small:

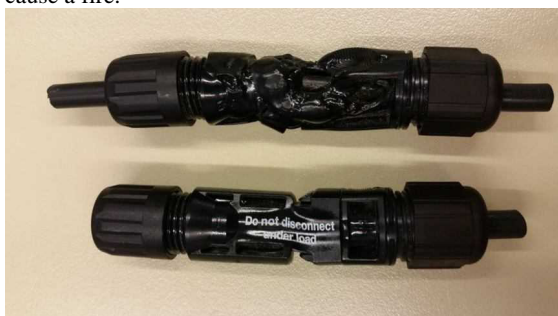
Figure 9: Failed Cross interoperability PV connectors Lumberg-MC of a BIPV-installation

In a 131 kWp in-roof installation in Switzerland, in spring 2015 this cross connectors were found. This could cause a fire.

Cross connections with different PV connectors must be avoided. It has to be seen as a serious technical deficit and must be replaced. Liability through insurance companies for such incidents has to be rejected. With a strict policy to ban the cross connectors, a weak point of PV installation could be eliminated.

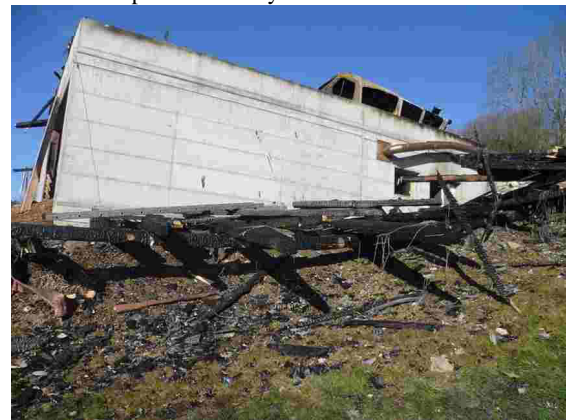
Figure 10: Workshop after the fire seen from east (position of the photographer first red circle on the map)

We took the opportunity after a fire in April 2015 in Lanzenhäusern near Berne. A farmer workshop got into a fire after welding activities. The roof integrated “Solrif” - PV installation of about 60 kWp with 205 Wp (CNPV-205-BLK PV modules) was completely destroyed. Through the strong west wind silicon particles would be distributed up to 2 km away from the site.

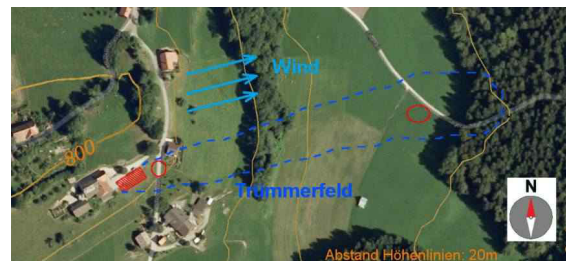
Figure 11: Situation in Lanzenhäusern (red surface – the workshop building) – first circle on the street position of the photographer/ second red circle: place of finding of silicon particles (see photo)

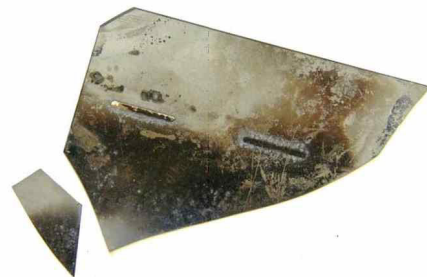
Figure 12: Silicon particle in the farmland – no further restriction for the use of the farmland

In the debris all components and materials of the PV installation can be found. In the farmland only silicon particles could be found. Investigation of the particles with SEM showed that mainly Al/ Si and O could be detected. This is not a problem for a further use of the land for agricultural purposes.

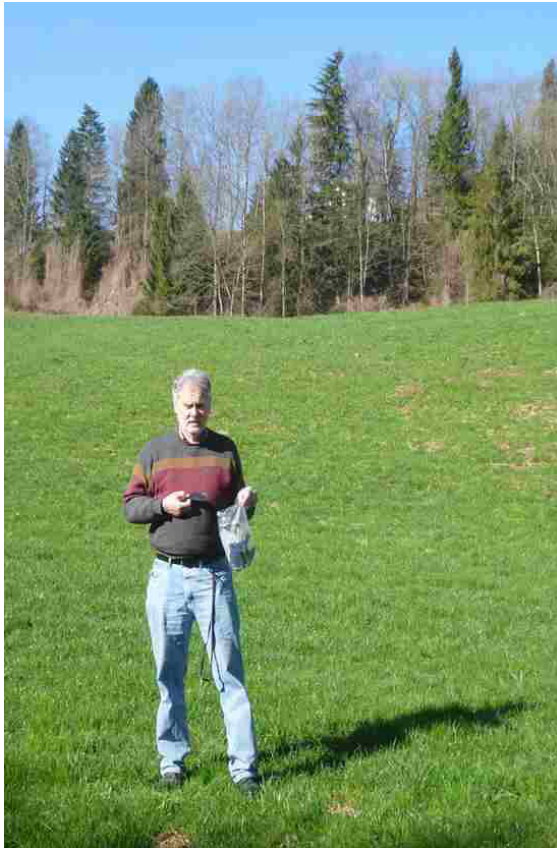
Figure 13: Finding spot (right circle) with silicon particles

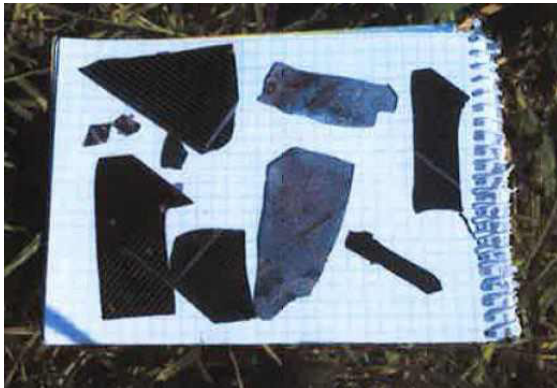
Figure 14: Silicon particles for the „cow“ – investigation – „green light“ even for cows

To check the compatibility of the silicon particles towards animals, especially cows, we contacted Prof. Dr. med veterinarian Samuel Kohler from the agricultural department of the Berner Fachhochschule<sup>8</sup>. Problems with horses, sheep, goats etc. could be quickly excluded. After further investigations also the “cow” got a “green light”. The silicon particles are so fragile that they will further smashed in the stomachs of the cow. Therefore silicon particle after a fire doesn’t cause serious problems for the farmers.

Together with material specialist of the Berner Fachhochschule we investigated the mixture of elements in those particles with a scanning electron microscope SEM. We could show that only silicon and aluminum oxide from the back side of the solar cell can be found in the particles. These particles could be eaten by animals as horses, sheep, pigs and cows. All the animals, without the cows, choose their food very carefully and wouldn’t eat such particles. The cows however would bring the particles into their stomachs. The silicon particles are so fragile that they will further smashed in the stomachs of the cow. Therefore silicon particles, after a fire, don’t cause serious problems for the farmers.
