NEW FINDINGS IN FIRE PREVENTION AND FIRE FIGHTING OF PV INSTALLATIONS

Prof. Urs Muntwyler

Berne University of Applied Sciences (BFH), Engineering and Information Technology
Photovoltaic Laboratory (PV-Lab), Jlcoweg 1, CH-3400 Burgdorf, Switzerland
phone: +41 (0)34 426 68 37, fax: +41 (0)34 426 68 63, urs.muntwyler@bfh.ch

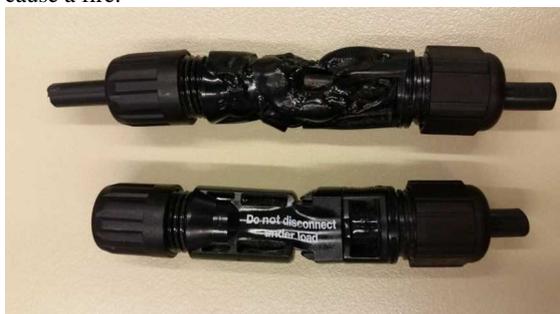
Figure 9: Failed Cross interoperability PV connectors Lumberg-MC of a BIPV-installation

In a 131 kWp in-roof installation in Switzerland, in spring 2015 this cross connectors were found. This could cause a fire.

Cross connections with different PV connectors must be avoided. It has to be seen as a serious technical deficit and must be replaced. Liability through insurance companies for such incidents has to be rejected. With a strict policy to ban the cross connectors, a weak point of PV installation could be eliminated.

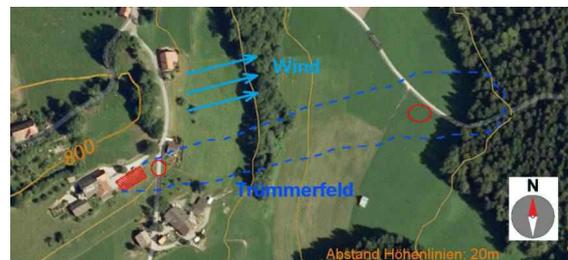
Figure 11: Situation in Lanzenhäusern (red surface – the workshop building) – first circle on the street position of the photographer/ second red circle: place of finding of silicon particles (see photo)

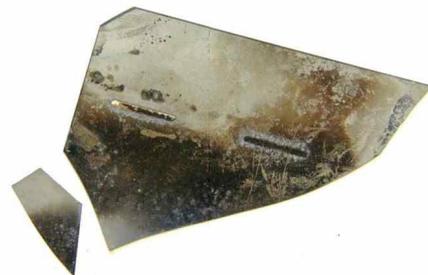
Figure 12: Silicon particle in the farmland – no further restriction for the use of the farmland

In the debris all components and materials of the PV installation can be found. In the farmland only silicon particles could be found. Investigation of the particles with SEM showed that mainly Al/ Si and O could be detected. This is not a problem for a further use of the land for agricultural purposes.

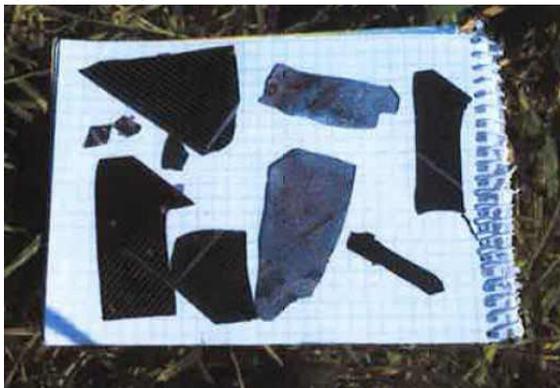
Figure 14: Silicon particles for the „cow“ – investigation – „green light“ even for cows

To check the compatibility of the silicon particles towards animals, especially cows, we contacted Prof. Dr. med veterinarian Samuel Kohler from the agricultural department of the Berner Fachhochschule⁸. Problems with horses, sheep, goats etc. could be quickly excluded. After further investigations also the “cow” got a “green light”. The silicon particles are so fragile that they will further smashed in the stomachs of the cow. Therefore silicon particle after a fire doesn’t cause serious problems for the farmers.

Together with material specialist of the Berner Fachhochschule we investigated the mixture of elements in those particles with a scanning electron microscope SEM. We could show that only silicon and aluminum oxide from the back side of the solar cell can be found in the particles. These particles could be eaten by animals as horses, sheep, pigs and cows. All the animals, without the cows, choose their food very carefully and wouldn’t eat such particles. The cows however would bring the particles into their stomachs. The silicon particles are so fragile that they will further smashed in the stomachs of the cow. Therefore silicon particles, after a fire, don’t cause serious problems for the farmers.
