# Monitoring climatic impacts on the moisture uptake of the first Swiss wildlife bridge made of wood

Karim Ghazi Wakili<sup>1</sup> · Marcus Schiere<sup>1,2</sup> · Sébastien Bonifacio<sup>1,3</sup> · Ulrich Kautz<sup>1</sup> · Jan Maurer<sup>1,4</sup> · Lukas Rügsegger<sup>3</sup> · Andreas Müller<sup>1</sup>

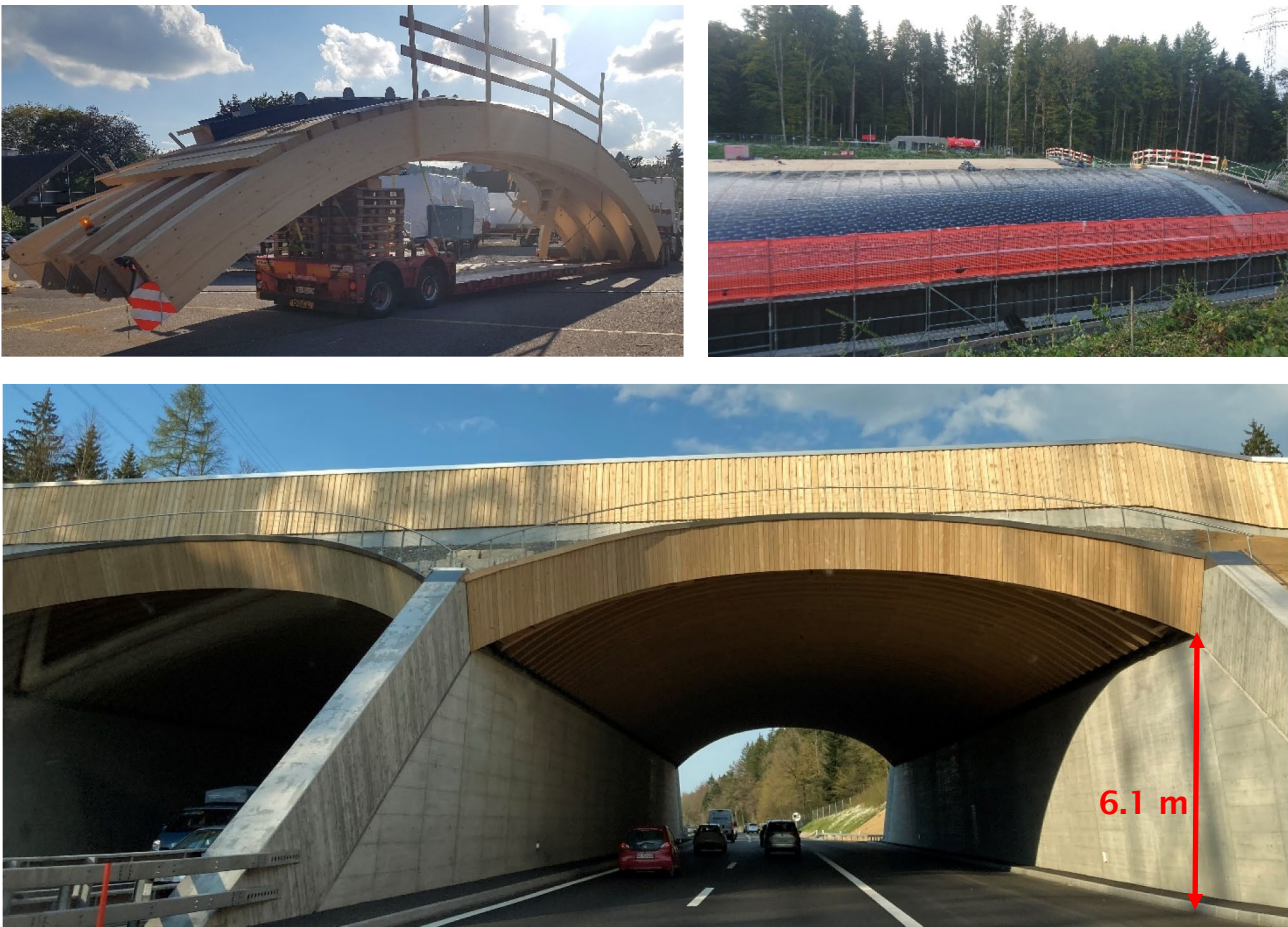
**Fig. 1** An element of the wooden wildlife bridge on its way to the installation site (top left), the finished construction with the bitumen layer before filling the roof with earth (top right), and finally the frontal view of the entry (bottom)

The presently investigated wildlife bridge (Fig. 1) is the first one in Switzerland made of wood-based materials and was completed in spring 2021. Its construction and installation procedure were reported by Timbatec (2021). This was a major achievement despite the old prejudice against wood in such constructions and a result of the motion «Research and innovation of wood as a material for use in infrastructure construction as a contribution to decarbonization» accepted in the Swiss Council of States and the National Council.

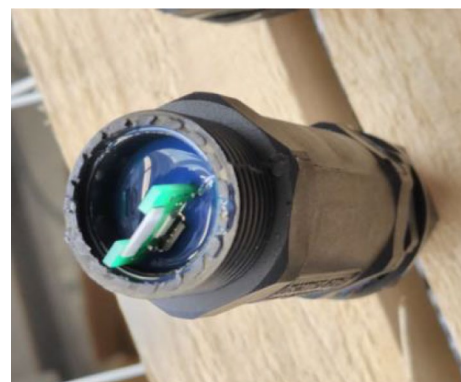
**Fig. 2** Sensor for measuring the relative humidity at different depth of the wood-based material by the sorptive method

The main part of the monitoring system consists of sensors measuring moisture and temperature of enclosed air cavities at different depths of the wood-based material (Fig. 2). This

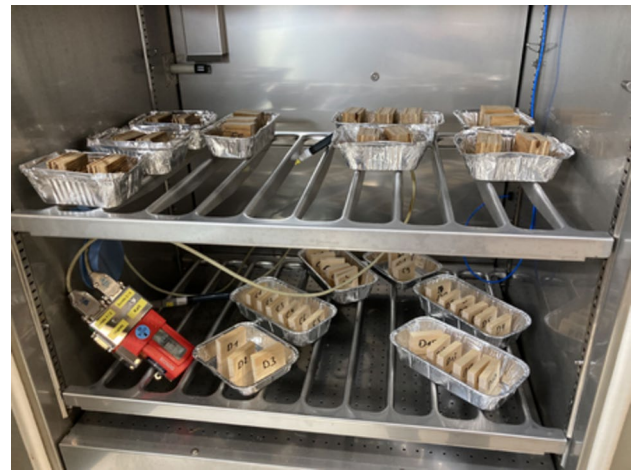
**Fig. 7** Test specimen in the climate chamber with data logger to check the actual boundary conditions (temperature and humidity)

In a first step, the samples were dried according to ISO 12570 (2000). The samples were dried in a drying oven for 7 days. The equilibrium condition of the standard was then met i.e., mass change < 0.1% after three consecutive measurements, each 24 h apart. Then the dry density of each sample was determined. In the next step, the sorption isotherm of each sample was determined according to EN ISO 12571 (2021). The dried samples were stored in a climate chamber under preset temperatures and relative humidity. The actual values were checked with calibrated sensors (Elpro Ecolog) as shown in Fig. 7.

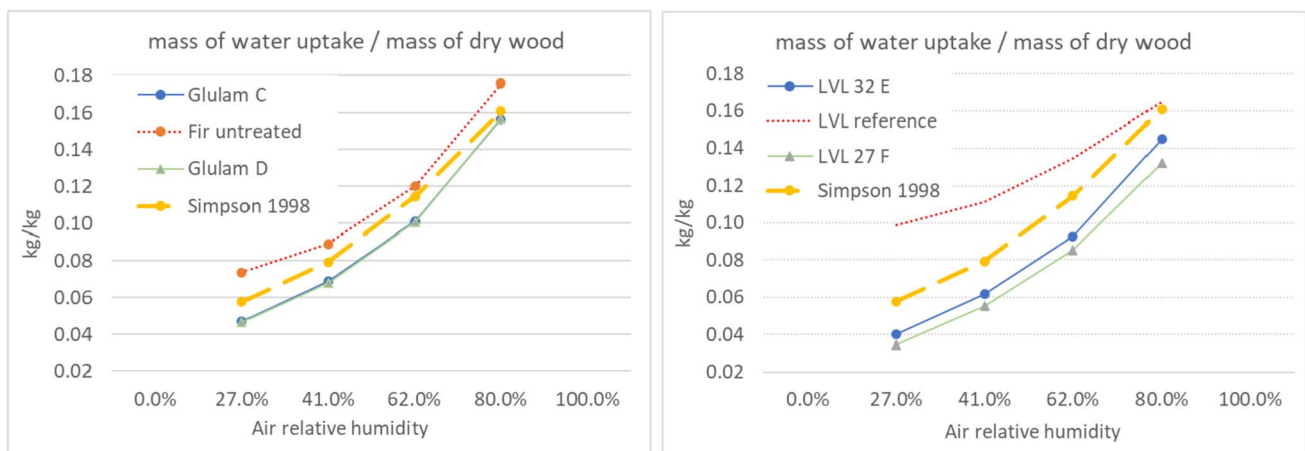
**Fig. 8** Sorption isotherms of the four investigated specimens: Glulam C and Glulam D not distinguishable (left), LVL E and LVL F (right) with values from the literature and according to Simpson (1998)

The resulting sorption isotherms show a lower water uptake for the investigated samples described in the previous section compared to values from the database of hygrothermic simulation tools (WUFI) and the approximative model (Simpson 1998) shown in dotted and respectively in dashed lines in Fig. 8. These lower values are due to the impregnation treatment. Pressure impregnation has a double effect on reducing the moisture absorption of wood. First, it reduces the number of -OH groups which are susceptible to attract water molecules and second, the cell walls become saturated with a monomer which is polymerized by applying pressure (Mendis et al. 2023).

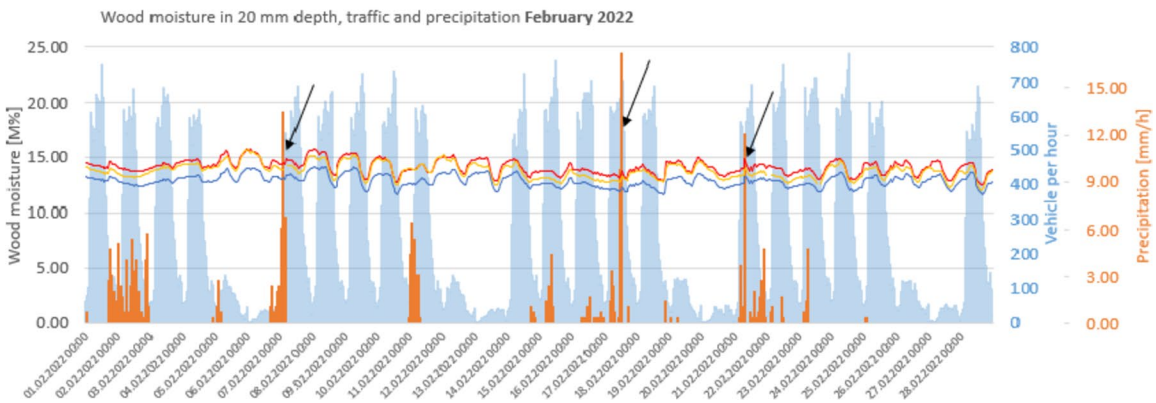
**Fig. 14** Wood moisture in 20 mm depth, traffic (orange), and precipitation (blue) for selected months (those with heavy traffic—precipitation coincidences) (Colour figure online)

From these months, only those were selected in which one or more coincidences of rain and heavy traffic occurred (Fig. 14). The sensors at the smallest depth (20 mm) were chosen because these would respond most readily to an increase in air humidity, i.e., the formation of water haze.

On July 7th, 8th, 13th, and 14th 2021, a coincidence of heavy traffic (grey blue) and precipitation (orange) can be observed. Similar coincidences occur on October 6th, 7th and 21st, on December 8th, 9th, 11th, and 29th 2021 and finally on February 3rd, 7th 12th, 18th and 21st 2022. The remaining months were not listed because they show no or only very weak precipitation-traffic coincidences and hence are irrelevant to the present argument.

On the dates mentioned above, a slight influence of the precipitation-traffic coincidence on the measured wood moisture content can be observed, in that the following minima of the daily fluctuations are less deep. In Fig. 14 these are marked with arrows. It can thus be plausibly shown that the simultaneous occurrence of heavy traffic and precipitation in this wooden wildlife bridge does not induce any relevant influence on the moisture in the wooden structure. This is of course also related to the size and height namely 6.1 m at the supportive walls and 8.1 m in the center of the construction (see Fig. 1). For lower ceilings this might be different.
