Quality assurance of timber structures

Research report

Report Nr.	77FE-008098-V01
Contract Nr.	2016.17
Classification	Public
Date	24.01.2019
Client	Bundesamt für Umwelt BAFU Abteilung Wald, WHFF CH-3003 Bern
Address of the research unit	Bern University of Applied Sciences Institute for Timber Constructions, Structures and Architecture Solithurnstrasse 102, CH-2504 Biel 6 Tel / Fax +41 (0)32 344 03 41/91 www.ahb.bfh.ch
Authors	Bettina Franke, Steffen Franke, Marcus Schiere, Andreas Müller
Project Leader	Prof. Dr. Steffen Franke
Head of the Institute	Prof. Andreas Müller

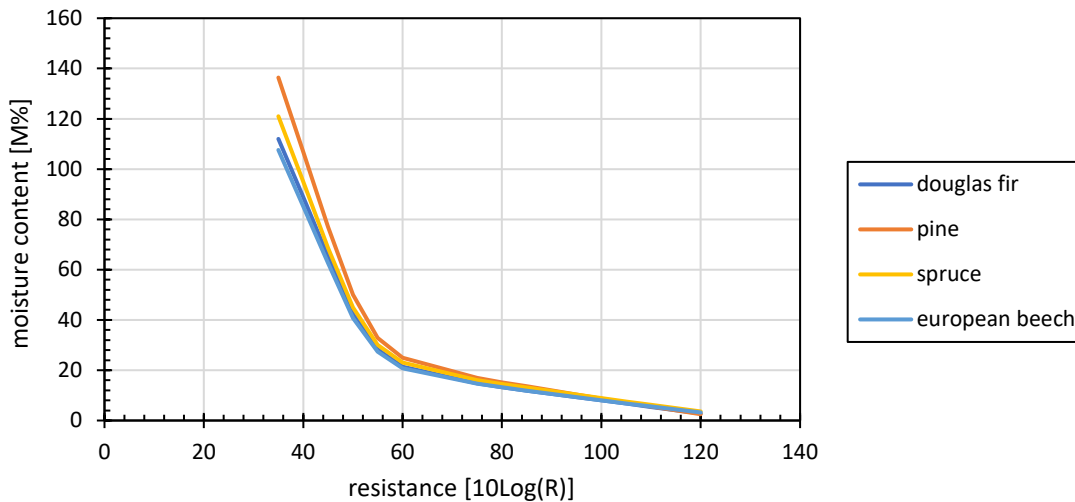
Figure 2: Illustration of resistance curves from electrical resistance to wood moisture content.

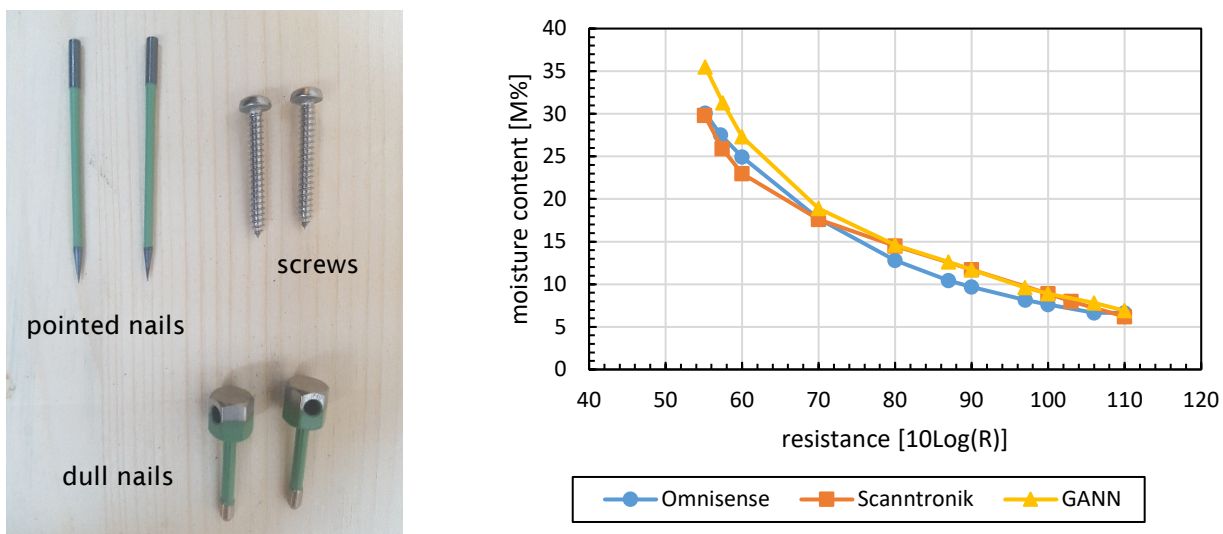
Figure 3: Electrodes used in the different equipment (right) and the conversion curves from electrical resistance to moisture content (left)

Whereas the moisture contents were generally measured using the equipment supplied by Scanntronik Mugrauer GmbH, moisture contents in the training facility of the ice hockey club of Davos (CH) were measured with the wireless sensors supplied by Omnisense®. Eight loggers powered by batteries were connected wireless with one gateway and could log and transmit both electrical resistance from about 6 M% upwards and two inputs for climate. Measured values are viewed online (paid service) and downloaded from a website to allow post processing afterwards. Moisture content is calculated directly and is valid for Douglas fir. Conversion for Norway spruce needs to be done afterwards. The electrodes suggested by Omnisense were screws. The electrodes and conversion parameters are shown in Figure 3.

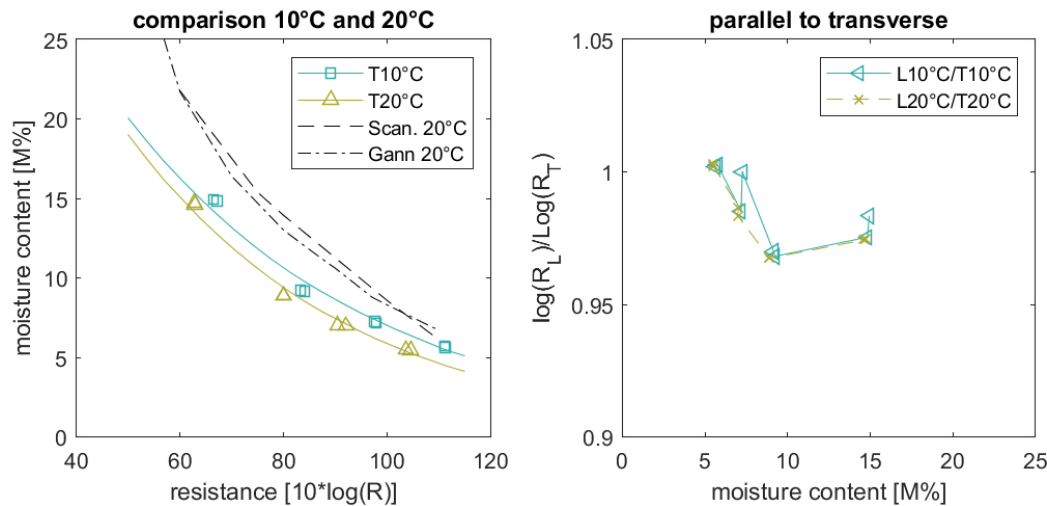
Figure 5: Measured resistance against moisture content transverse to the grain at 10 °C and 20 °C and the resistance curves for beech as programmed in the soft and hardware of Scantronik and Gann Hydromette M 4050 (left); relation between resistance measured along the grain and transverse to the grain (right).

Figure 5 shows that use of beech veneer can lead to significant over estimation of moisture content in the higher moisture content ranges, up to 5 M% in relative humidities of 83 %RH. The error is in the order of 2 M% in the low moisture content ranges. Determining the relation between resistance and moisture content on beech veneer proved to be necessary to allow a better determination of moisture content in the future.

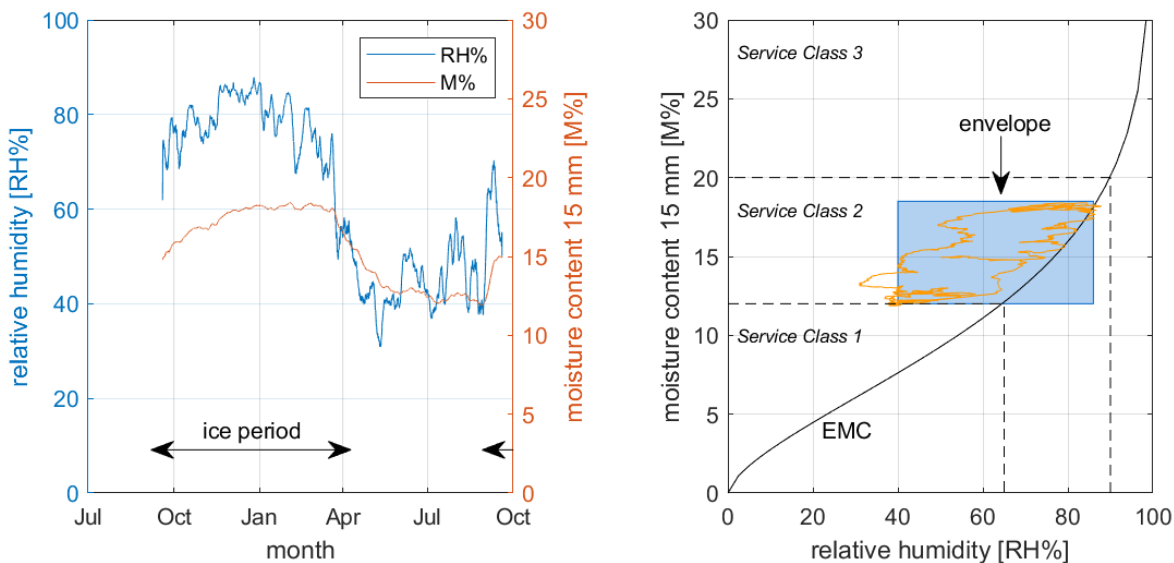
Figure 10: Example of data extraction of the data from ice rink B2 at measurement location M2 with the time series (left) and the comparison of relative humidity and moisture content at 15 mm depth (right); measuring data used from Gamper et al. (2014)

All the gathered time traces of moisture content and climate are shown in Appendix A. The measured data is analysed using the minima and maxima value over one year. This is done both for the wood moisture content and climate and presented as an envelope of the measure data. The developed envelopes can be used by practicing engineers and planners a support tool towards the design of a building. They also quickly allow to assess whether measured moisture contents are in ranges where the relative humidity is measured. Figure 10 shows the annual developments of relative humidity and moisture content over a year (left) and a comparison between the two (right). The moisture content was measured at 15 mm depth. The period where the ice rink is in operation is easily distinguished, i.e. from 1st September to 15th of April. The plotted data was filtered with a moving average filter.

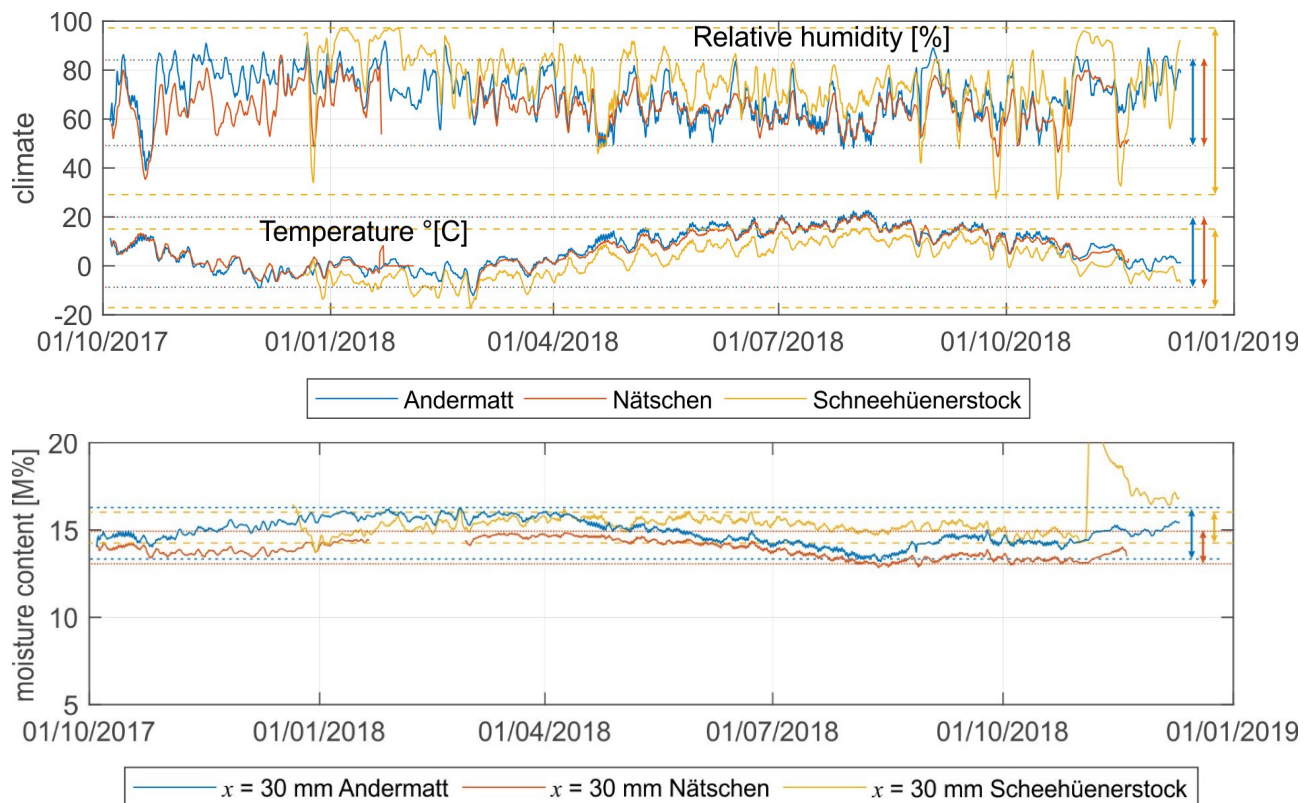
Figure 13: Climate and moisture content monitoring in the alpine region of Andermatt-Sedrun

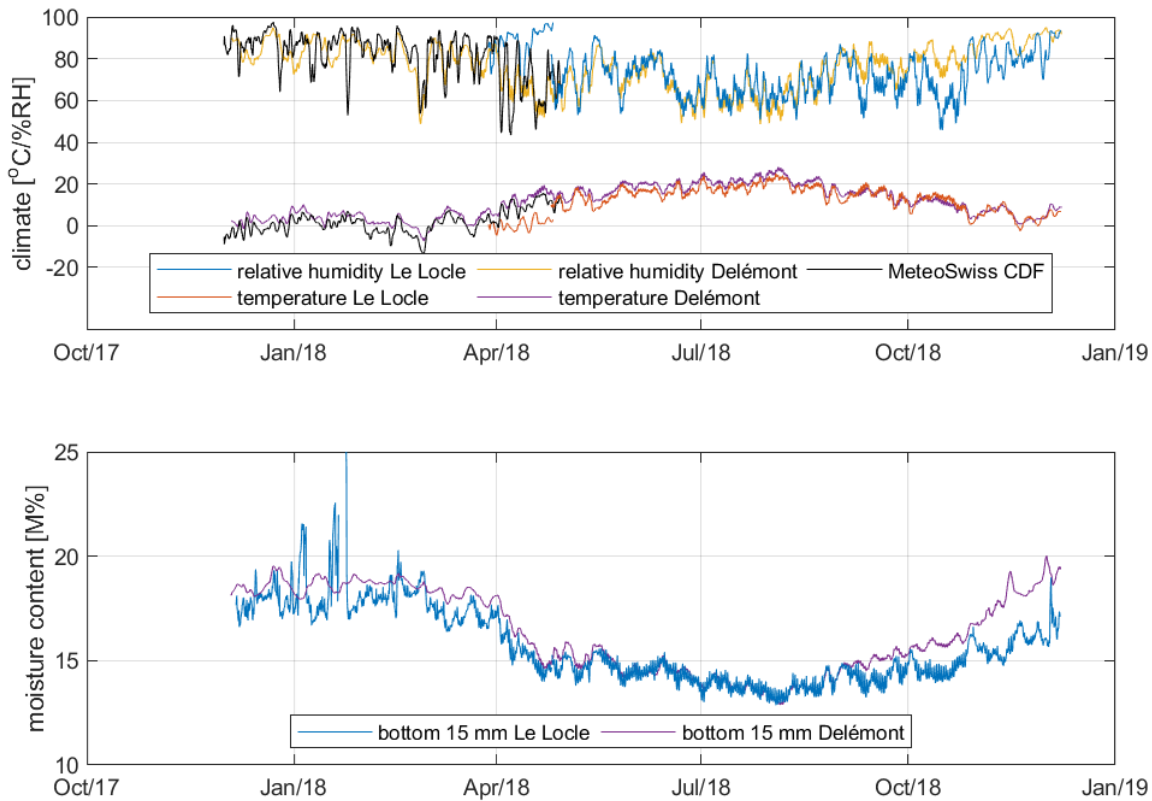
Figure 21: Measured climates and moisture contents on the bottom faces of the load bearing beams in the ice rinks of Le Locle and Delémont

During visits of the ice rinks of Delémont and Le Locle, traces of water are however clearly visible on the structure and roof. In autumn and winter, ice formation on the bottom side of the load bearing members was observed, as well as decolouration of the lower one or two lamellas of beams in the trusses. The situation could unfortunately not be inspected closely but can be seen Figure 19 bottom right. Apart from the ice formation, the ice rink's personnel also mentioned occasional fog formation inside the ice rink on otherwise clear days. In Delémont an extra ventilator was used to in these cases to improve ventilation throughout the structure. Traces of fungi or decay are not observed in either structure suggesting that the annual variation of climate also provides sufficient drying capacity throughout the rest of the year.

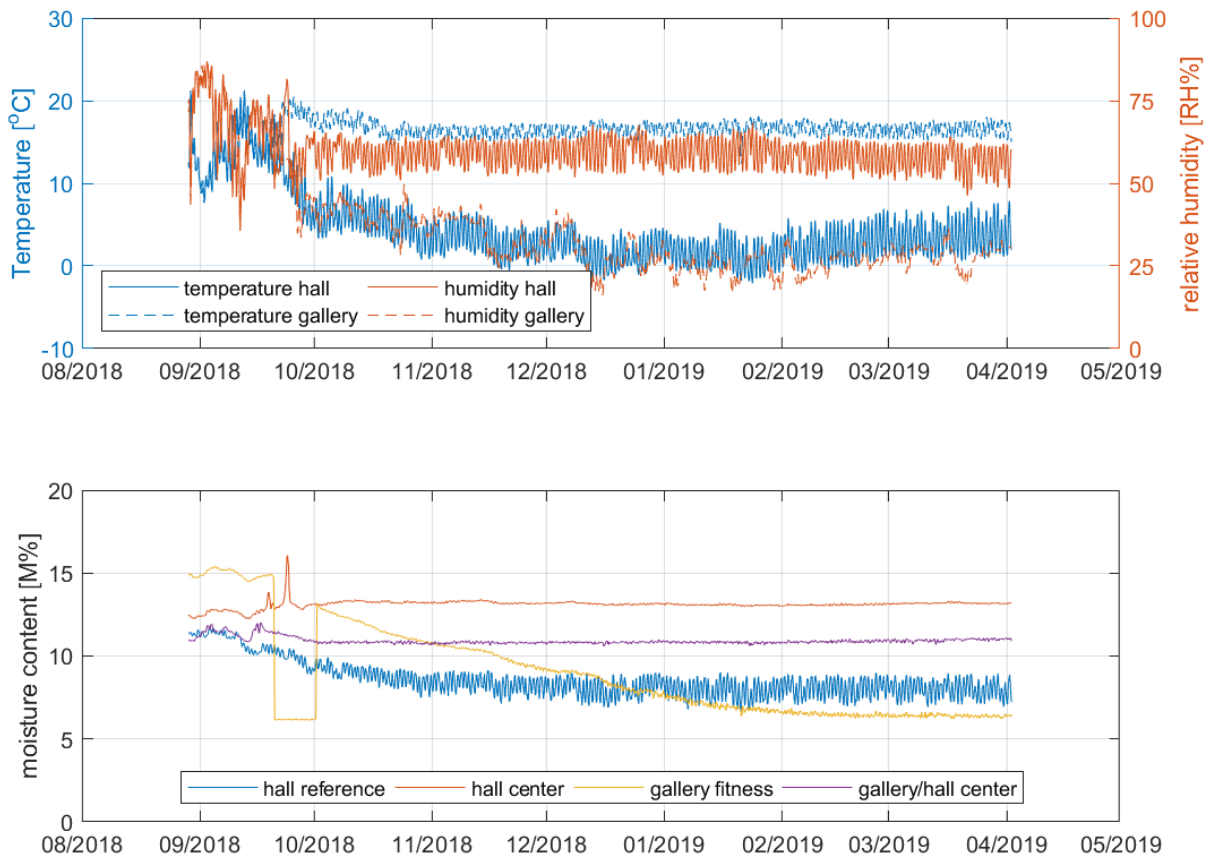
Figure 23: Summary of the measured climate and moisture content (depth of 15 mm) in the training facility of the Davos ice hockey club

A summary of the measured climate and moisture contents are observed in Figure 23. The figure shows the differences between the temperatures and relative humidities of the ice rink and fitness facility on the gallery. The moisture contents of the structure located above the ice is around 12 M% to 13 M%, except for the gage located above the tribune. The moisture content measured in the heated fitness facility reduces significantly. The development of moisture content in the load bearing member supporting the gallery seems to be little reason for concern (bottom plot) as moisture contents are between 9 M% and 12 M%. Two sensors temporarily malfunctioning due to a disconnected cable.

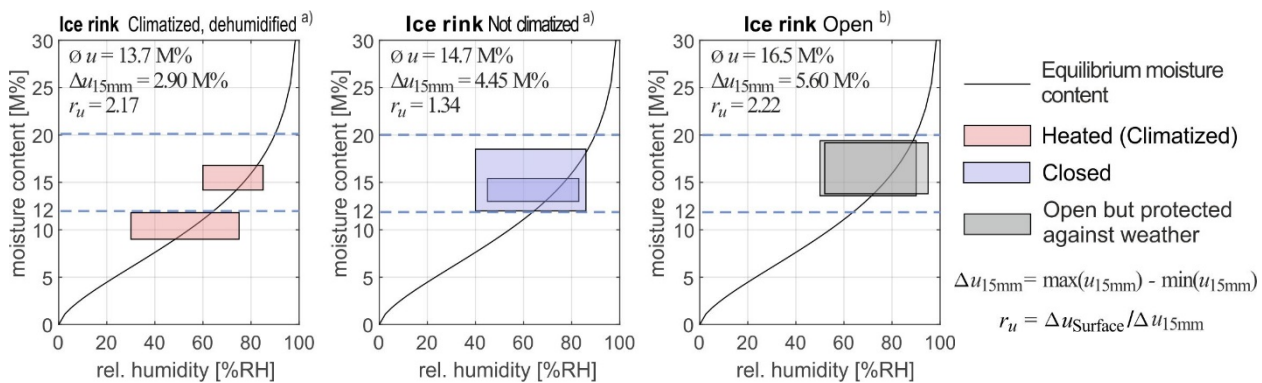
Figure 24: Envelopes of the moisture content for ice rinks, distinguished after operating service and construction type

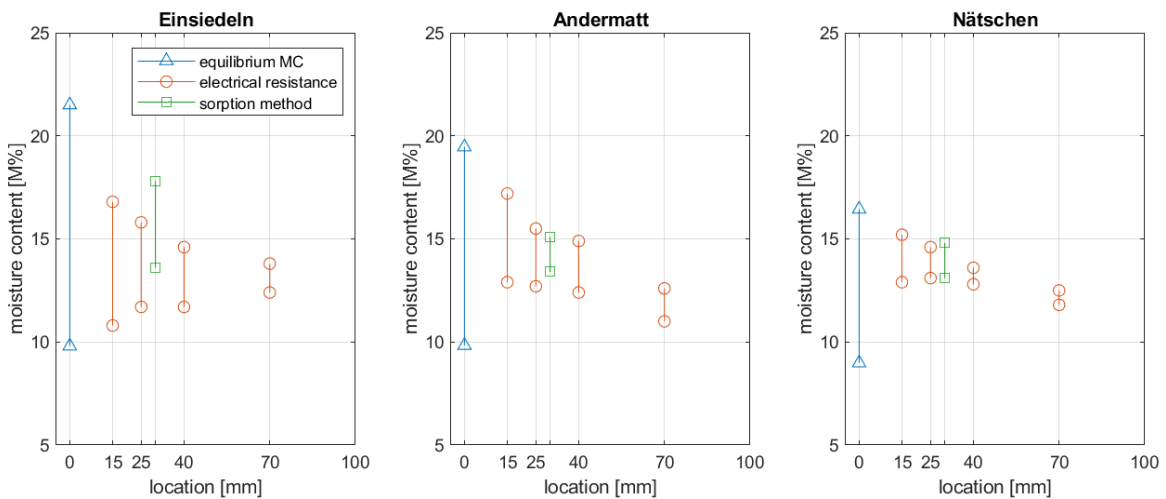
Figure 25: Moisture content measurements at different depths from the surface and different methods

Some care must be taken using the moisture contents measured in Andermatt and Näschen as these were measured close to, or around freezing temperatures. As the peaks were omitted though it is expected that the plotted moisture contents are representative enough. Temperatures at the station of Schneehüenerstock were lower and electrical resistance measurements are more unreliable. The figure shows though that the average moisture contents at the inner parts of the cross-sections are lower than at the surface. As measurements are continued, it will be interesting to see if how quickly the annual equilibrium is achieved.

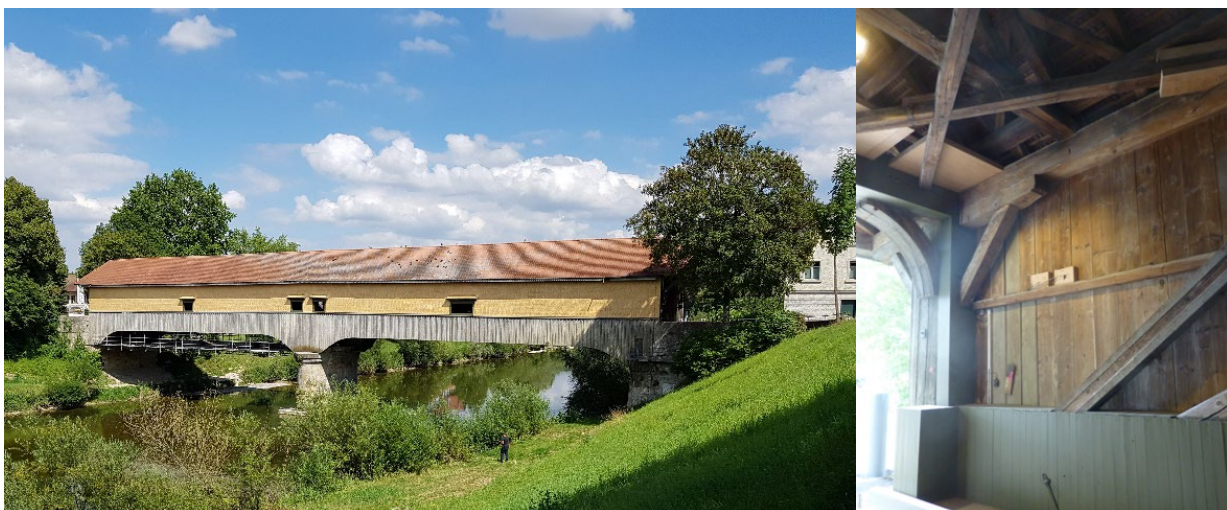
Figure 30: Bridge crossing the Thur in the village of Andelfingen with a view on the instrumentation and two dummy blocks on the north side of the bridge

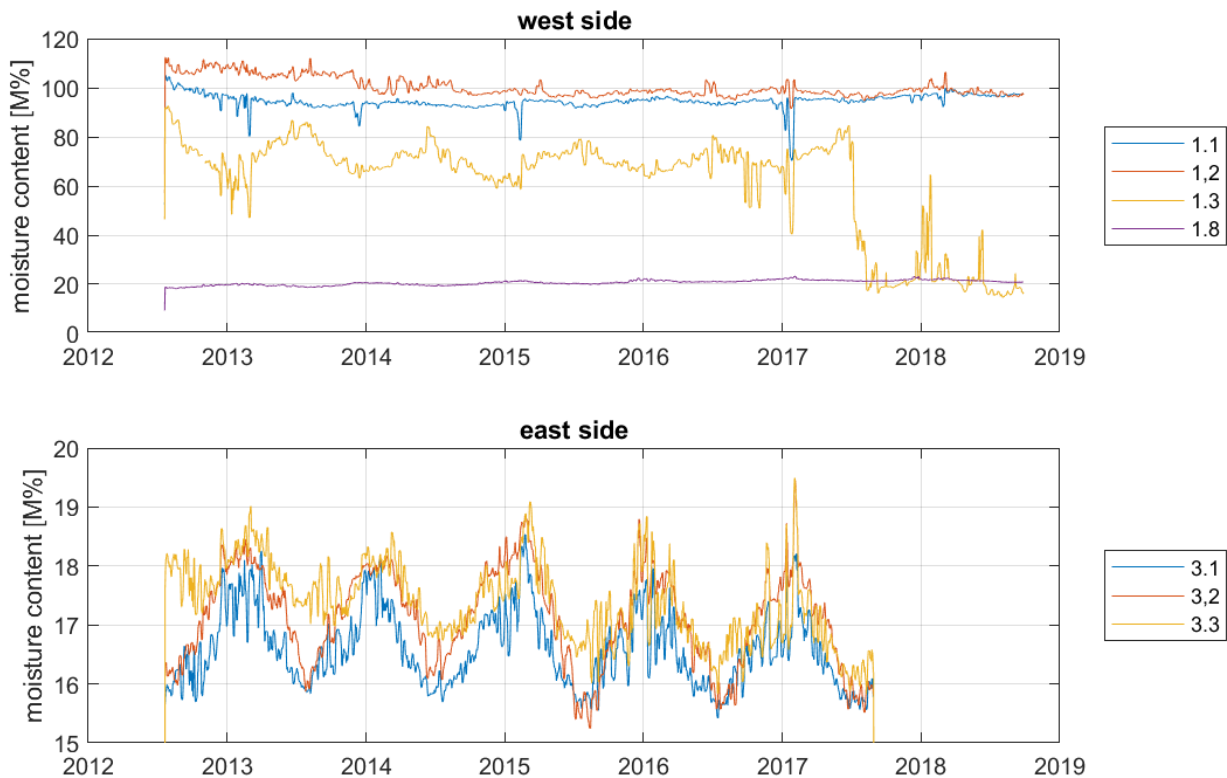
Figure 34: A summary of the moisture content measurements made on the Bubenei bridge

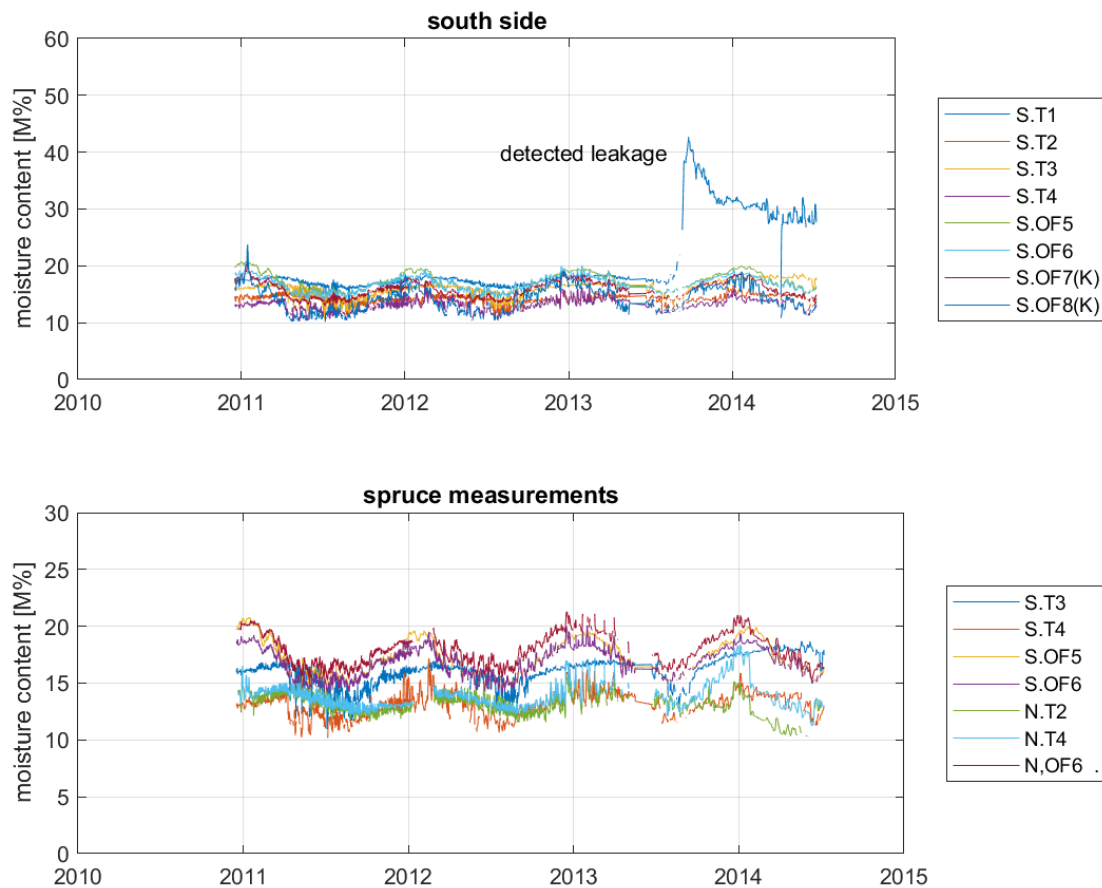
Figure 35: A summary of the moisture content measurements made on the Obermatt bridge where a leakage could clearly be detected thanks to the installed monitoring system.

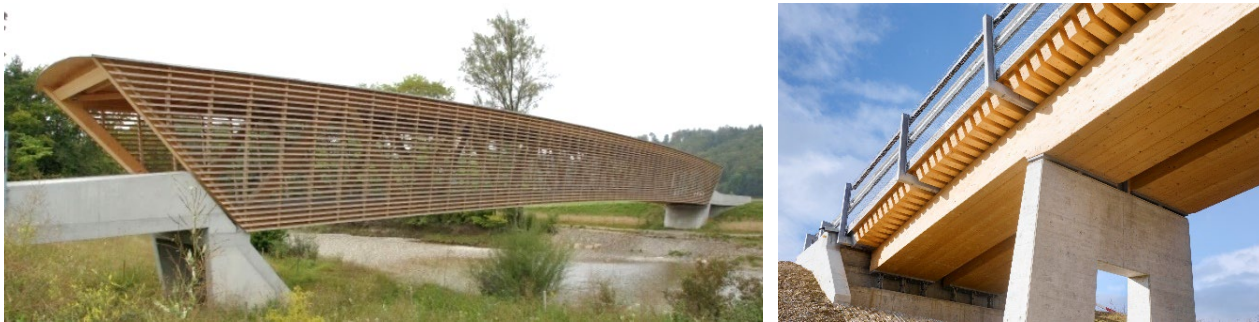
Figure 39: Bridge Neumatt with protected truss system using gladding (left) and Bridge Horen with weather protection by structural overhang

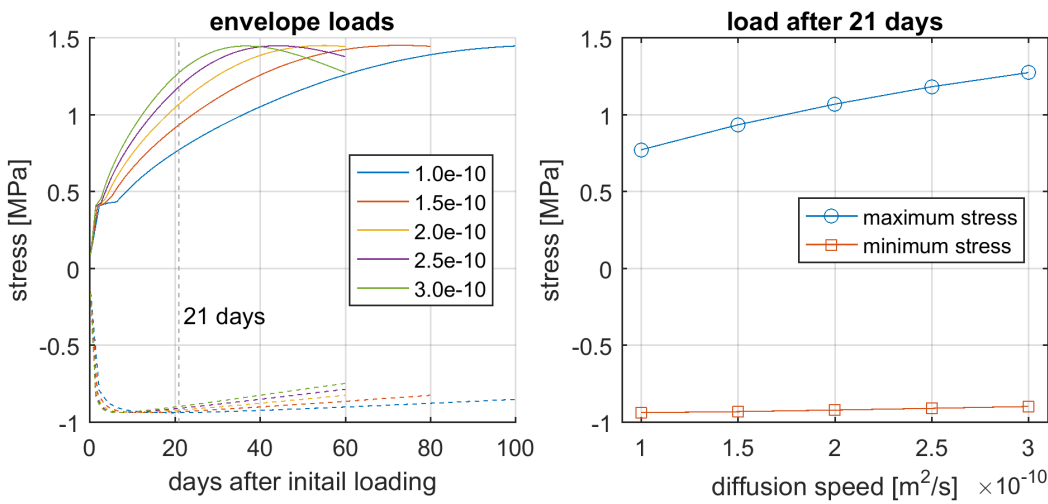
Figure 54: Development of moisture induced stresses in a 200 mm wide cross-section loaded by a stepwise moisture increase of 6 M%

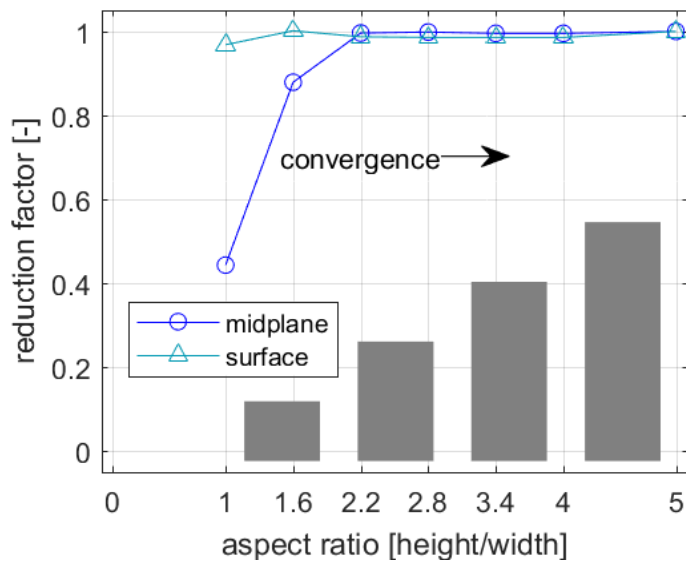
Figure 60: Effect of aspect ratio on stress levels on the surface and midplane of a glulam cross-section

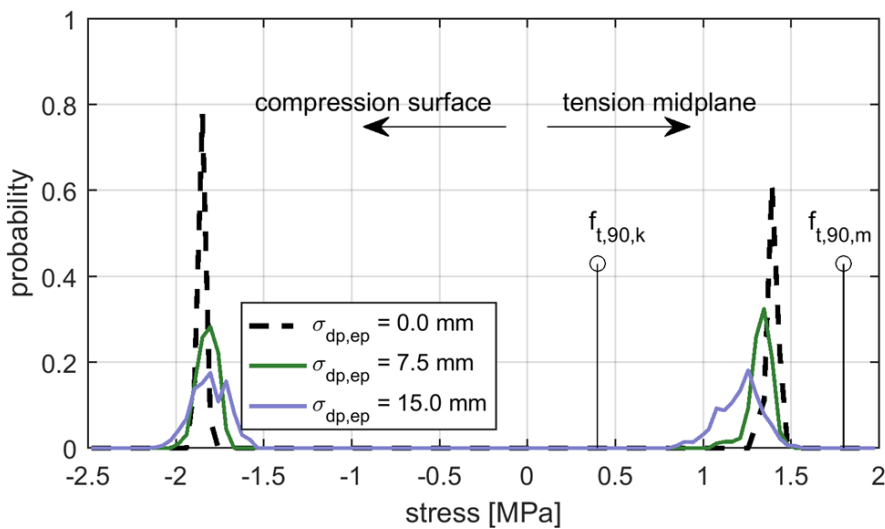
Figure 65: Effect of pith spread on minimum and maximum stresses occurring in the midplane and surface under wetting loads

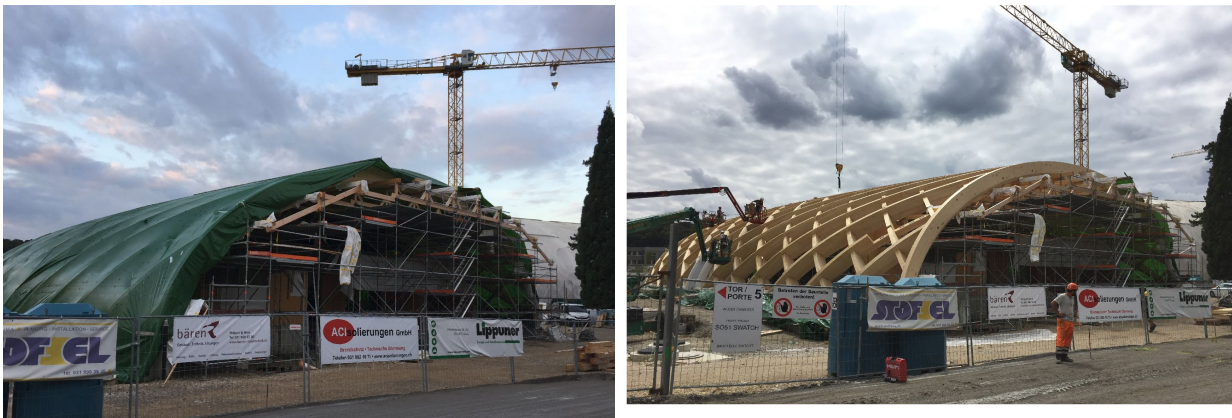
Figure 67: Efficient protection during evenings, nights and weekends or during rain; removing of the protection during the working times (Swatch building, Biel/Bienne)

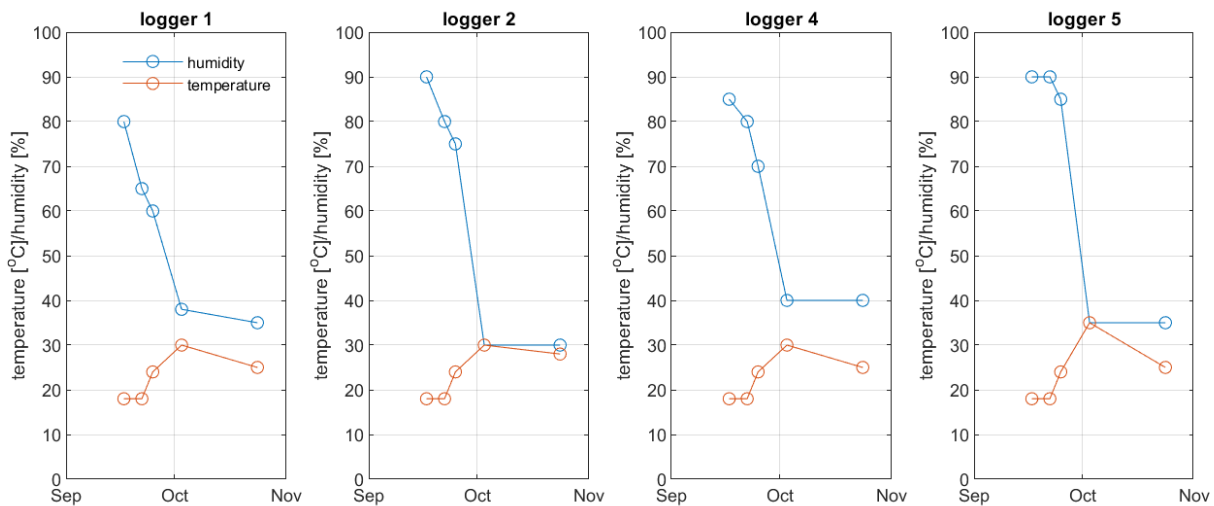
Figure 69: Summary of the measured humidity and temperature obtained from ‘Quellgarten’ on four out of six loggers (raw data not used)

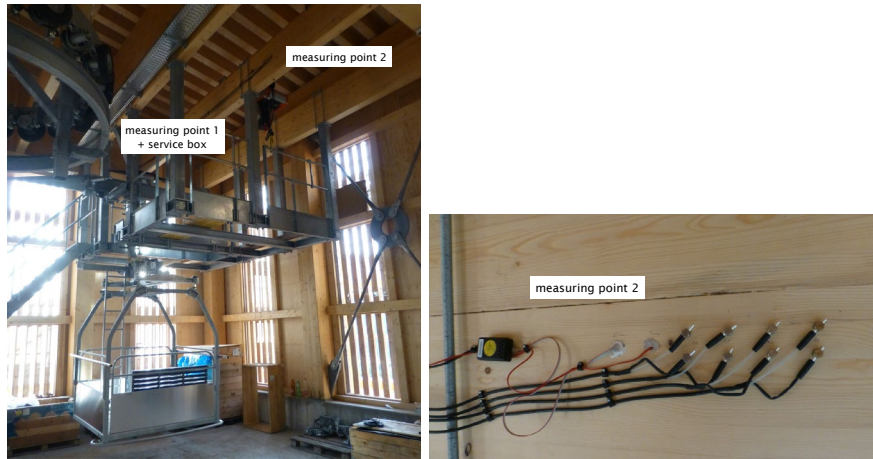
Figure 3: Measured climate and moisture content in the cable car station of Nättschen

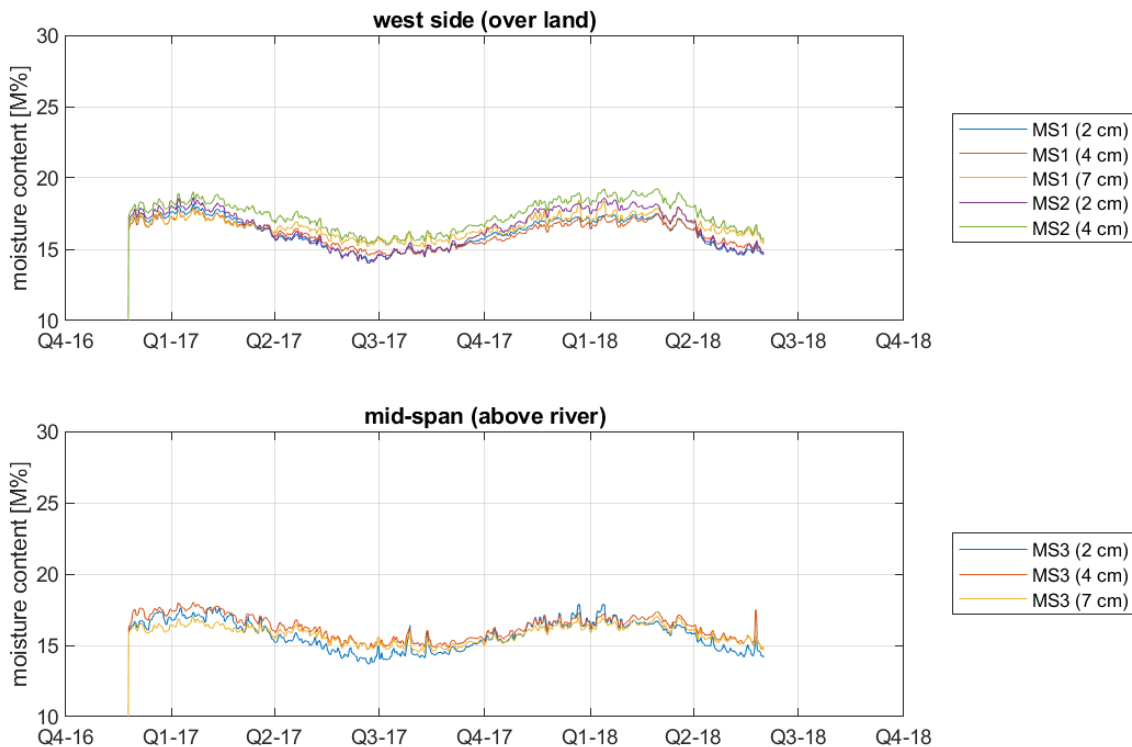
Figure 20: Measured moisture content on the bridge Werdau (DE) for nearly two years
